Technical Report 32-1284

*Temperature Control of the Mariner Venus 67
Spacecraft*

L. N. Dumas

JET PROPULSION LABORATORY
CALIFORNIA INSTITUTE OF TECHNOLOGY
PASADENA, CALIFORNIA

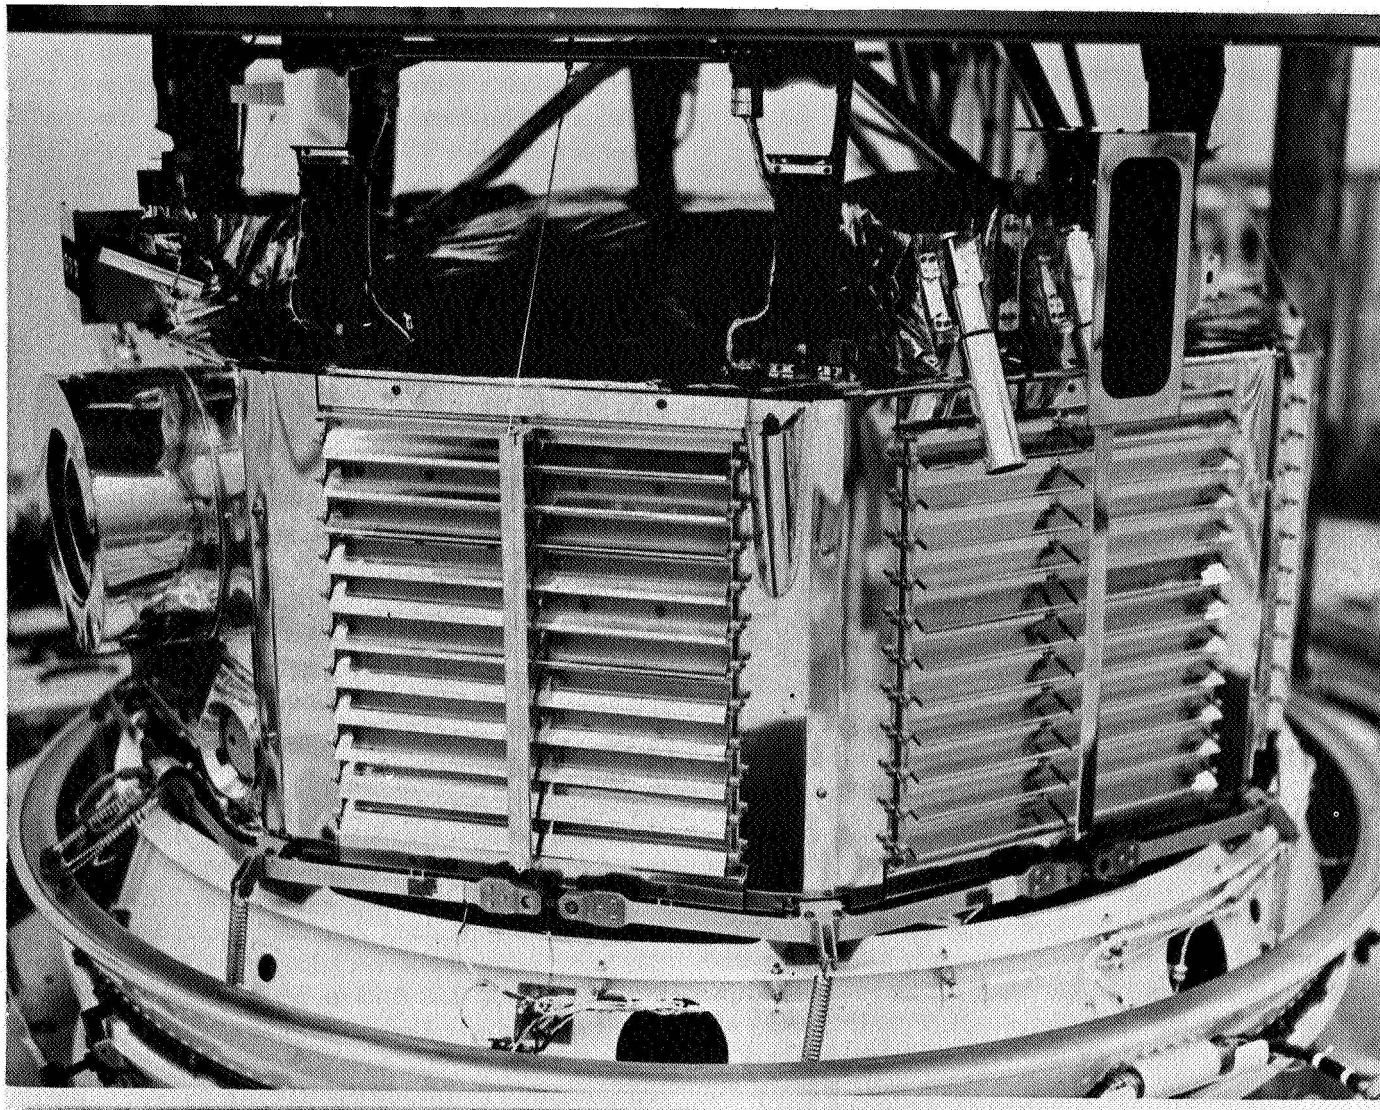
Fig. 5. Mariner V on Agena adapter

The *Mariner* Venus 67 variable emittance louvers were mounted on six of the seven electronic bays. Figure 5 shows typical louver installations on the flight spacecraft. Each louver assembly weighed 1.35 lb and covered an area of 1.62 sq ft. The effective emittance varied from 0.15 to 0.7 over a 30°F actuation range. Incipient opening was 55°F on bays 7 and 8, 60°F elsewhere. Eleven pairs of louver blades on each assembly were individually controlled by means of a spiral, bi-metallic element.

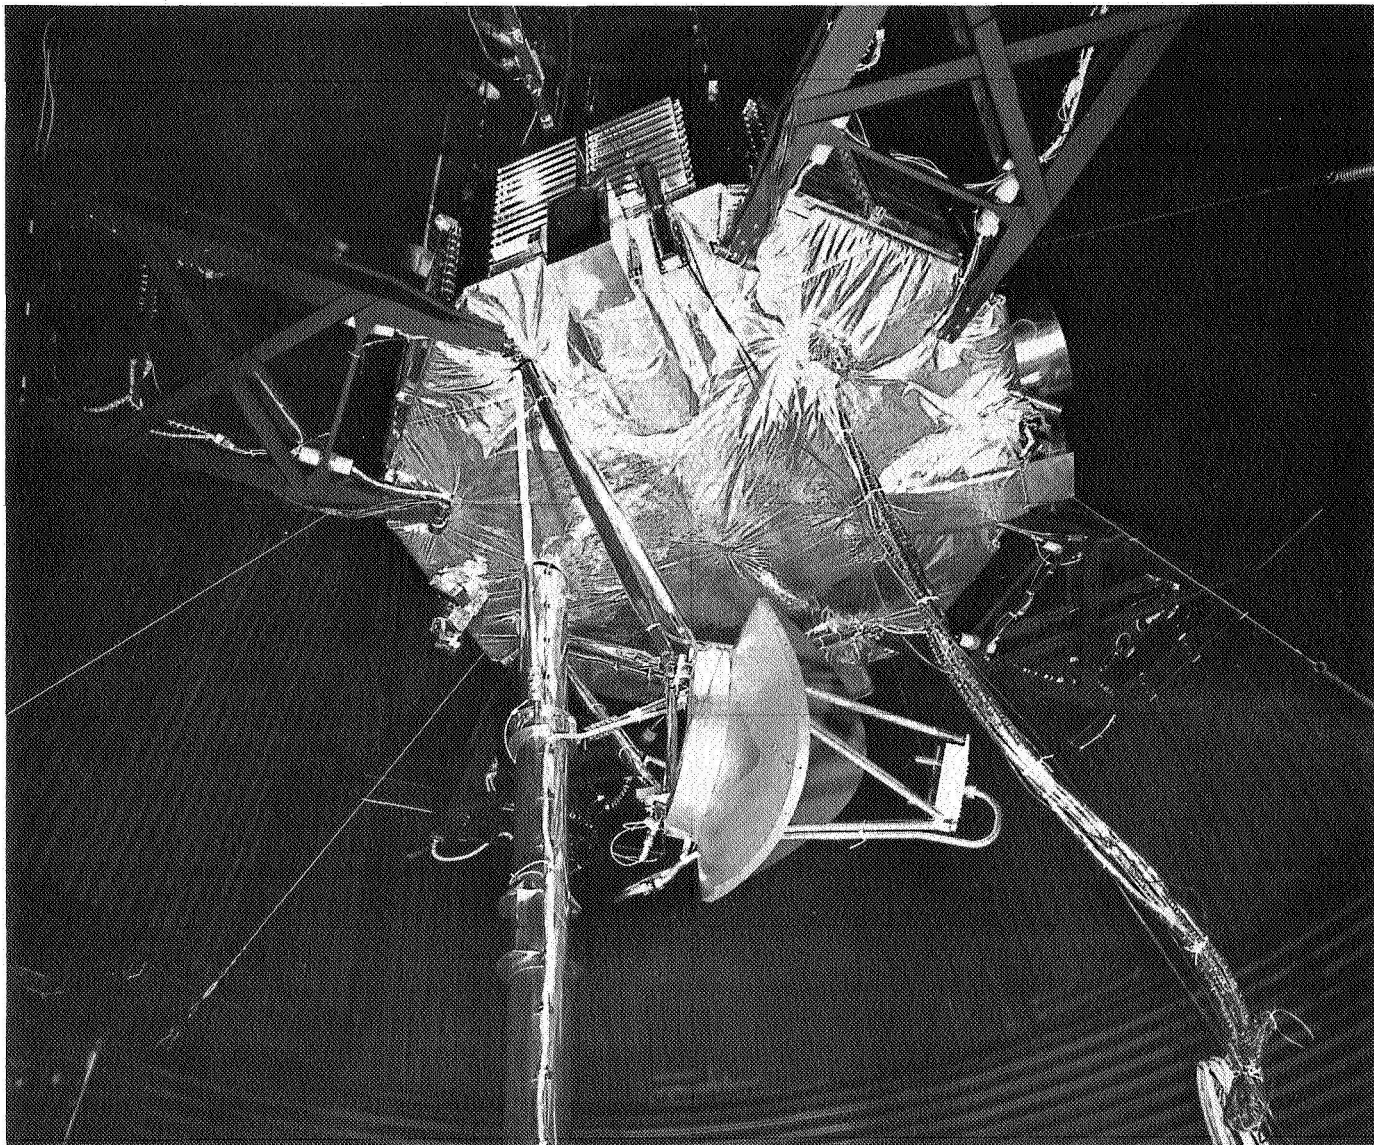
Fig. 13. TCM in JPL 10-ft space simulator

The test series was performed in three parts. Part 1 established that the temperature control provisions were adequate for the coolest and warmest modes during the primary mission. An additional mode at 285 W/ft² was performed because intensity monitoring radiometers disagreed. Minor changes to the trapped radiation detector (TRD) and magnetometer were made at the end of part 1.
